CERTIFOAM SERVICES, INC.  
P.O. BOX 5524  
WINSTON-SALEM, N.C. 27113  
919/744-7418

The following report consists of steps taken under 40 CFR  
280.62-65 in remediating a site occupied by Cartner's  
Service Center, Rt. 1 Box 249, Mocksville, N.C., 27028.

Site: Cartner's Service Center  
US 64 @ SR 1143 (Davie Co.)  
Mocksville, N.C. 27028

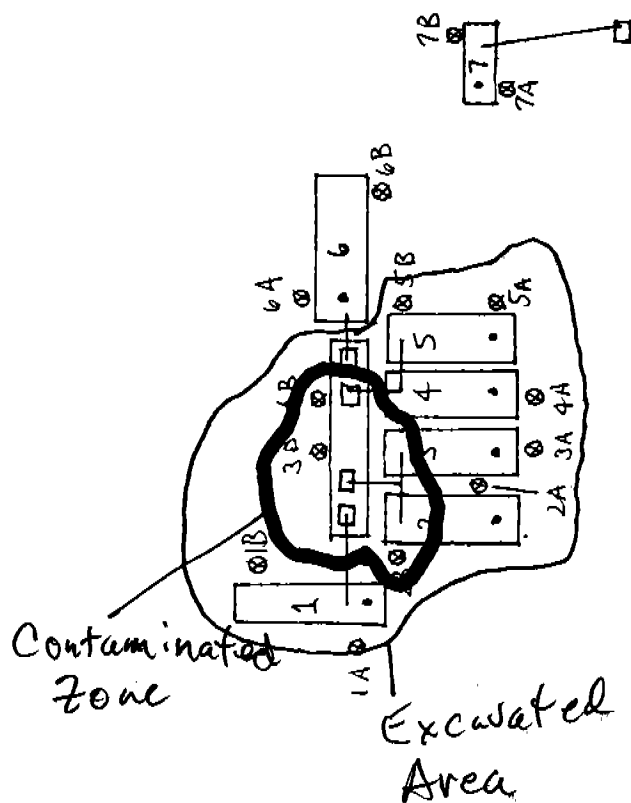
(1). On March 30 & 31 Stroud Brothers Grading excavated the impacted area. I came on site on the 31st with my flame ionization detector to determine if any contaminated soil remained. Some did, and it was removed. The excavated area is noted on the enclosed map.

Digging was done to a depth of 14' before all contaminants were removed to a level of 40-50 ppm per my FID.

Here, I inspected all tanks and found them to be in excellent condition. Consultation with the backhoe operator indicated the leak was centered under the two pumps located on the gas island directly toward the road from tanks #2 & #3.

(5). As noted earlier, the release was confined to the area directly under the island area. FID scanning indicated that the majority of the impacted soil has been removed; what is

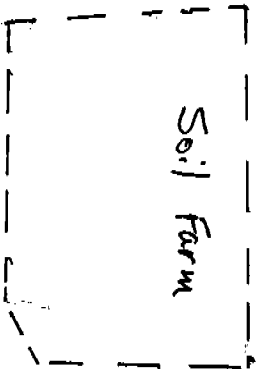
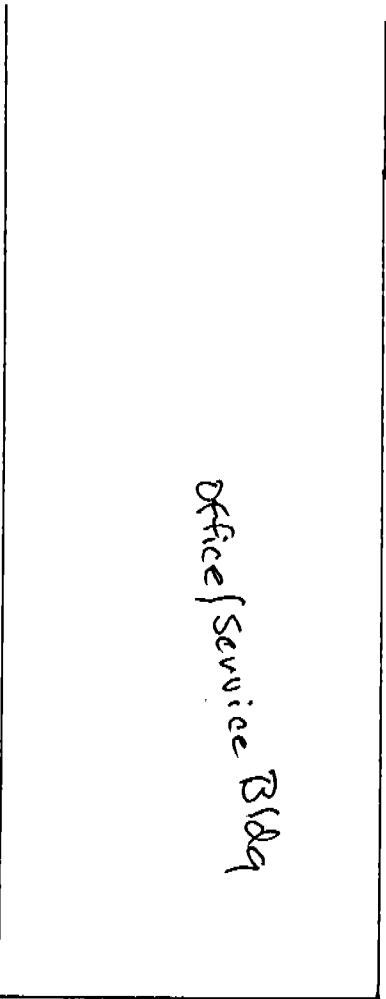
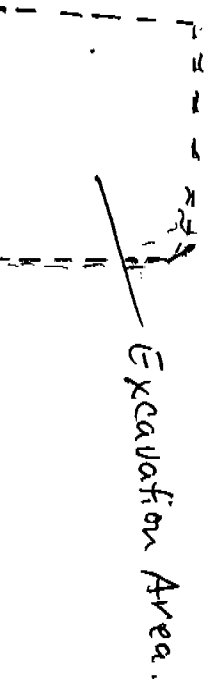
(4). The impacted dirt was removed to the rear of the property as noted on the diagram. Here, a soil farm was constructed according to DEM regs with plastic underneath and on top with hay bales used to contain any side seepage. The amount of dirt removed is approximately 300 yards.

Note: Soil is between 2'-5' deep  
in the farm.
